Ruptured Weld Cause Of Pipeline Explosion

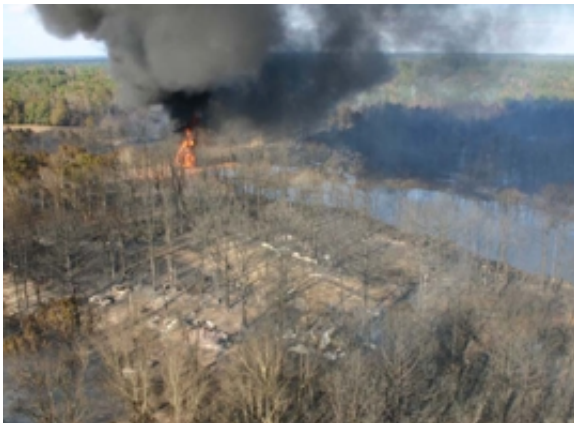
The subsequent fire destroyed homes and burnt woodland.
